North Bay Twenty Years Later – A Case Study of Proper Design and Construction of
Interlocking Concrete Pavement

Brian R. Baker, P. Eng., Managing Director of Public Works for the City of North Bay
Robert J. Burak, P.Eng. Director of Engineering for the Interlocking Concrete Pavement Institute

Paper prepared for presentation

of the 2003 Annual Conference of the
Transportation Association of Canada
St. John’s, Newfoundland and Labrador

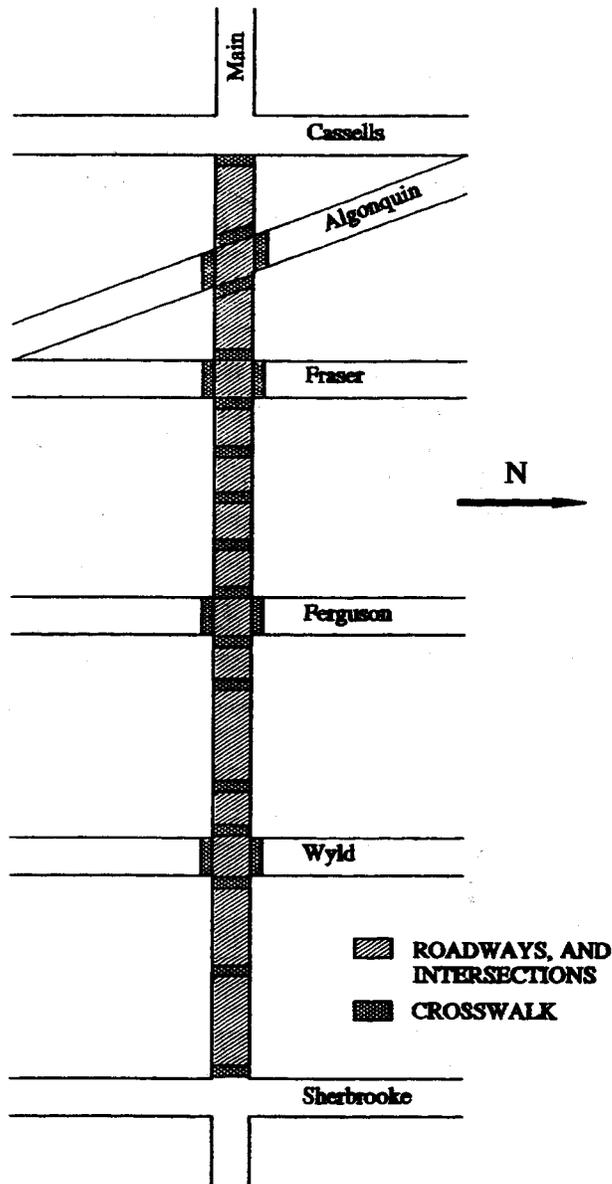
Figure I: Site layout of the reconstruction of Main Street North Bay – 1983
Source: PCS/Law Engineering

The reconstruction of Main Street covers an area of 13,935 m² (150,000 ft²), including sidewalks and roadways. In total, it extends just over 1 km (3300 ft). Figure I shows a plan view of the

installation along Main Street extending from Sherbrooke Street to Cassells Street and Figure II shows the site before construction in 1982. As part of this major reconstruction, all underground services were replaced and a completely new streetscape was constructed on the full width of the 66' (20.2m) road allowance, which had buildings immediately abutting the property line throughout the entire length of the project.

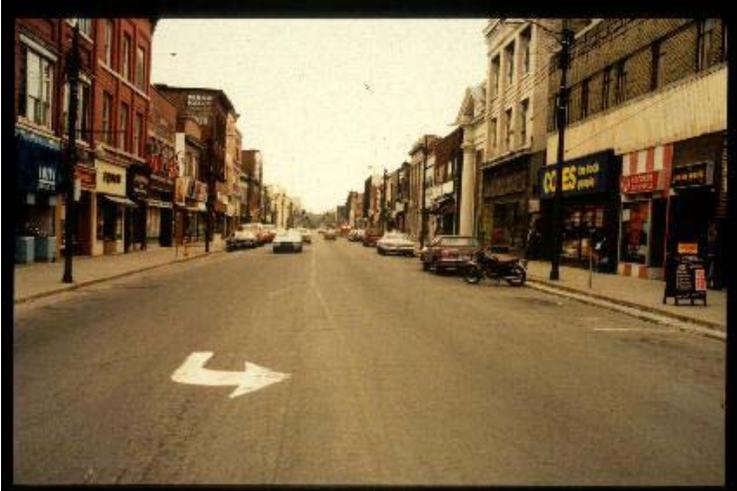
Figure II: Main Street North Bay before 1983 re-construction

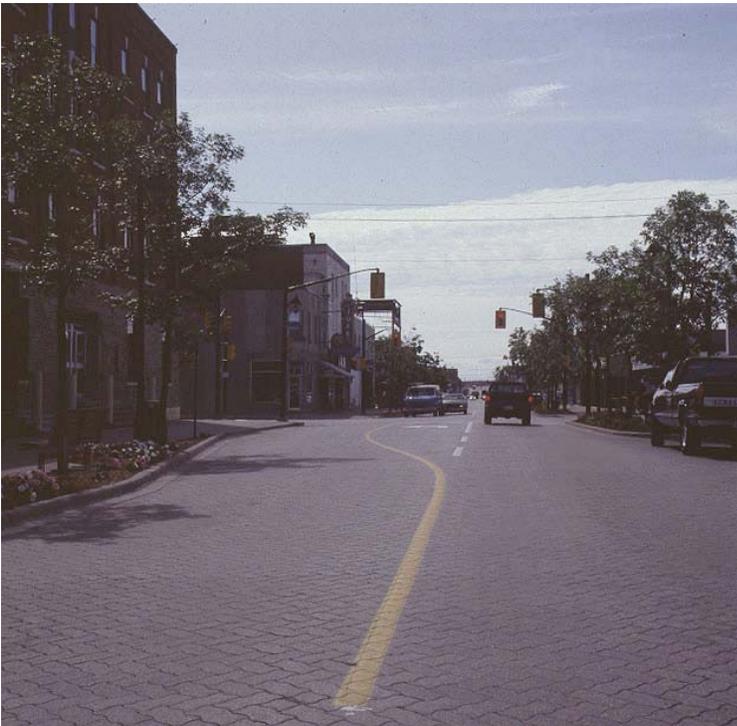
Figure III: Main Street North Bay immediately after re-construction – 1983
Overhead wiring was removed in 1984

Figure III is a view of the completed work in 1983. While the two-way traffic on Main Street is approximately 8,000 vehicles per day, the intersection of Algonquin and Main Streets sees approximately 13,000 vehicles per day. Approximately 5% of the traffic consists of buses and trucks. The pavements in North Bay are subjected to severe weather conditions with temperatures ranging from - 40 C to + 35 C. In addition, North Bay receives an average of 990 mm of precipitation each year, and Main Street itself receives approximately 270 tonnes of a rock salt/sand mixture each year (See Figure IV).

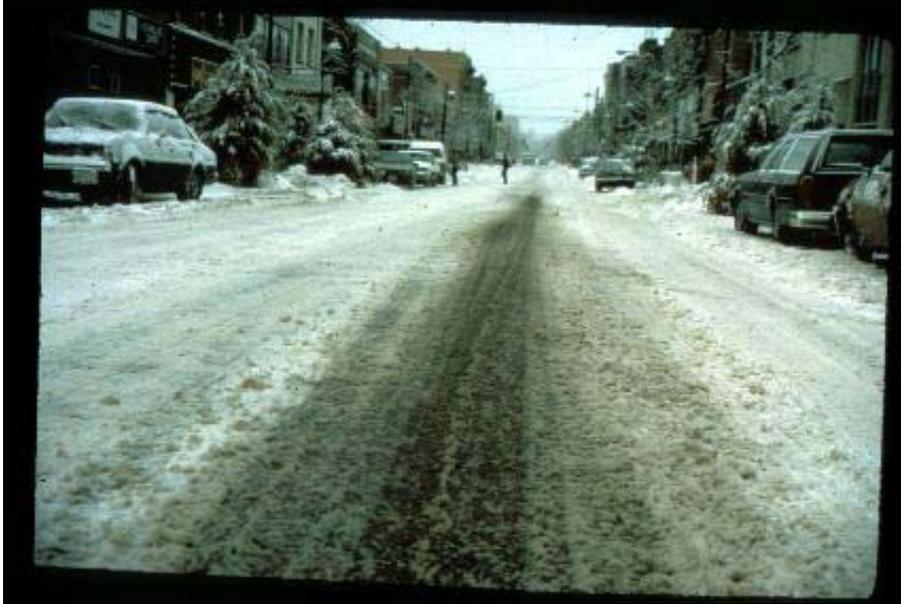
Figure IV: Typical winter conditions in North Bay

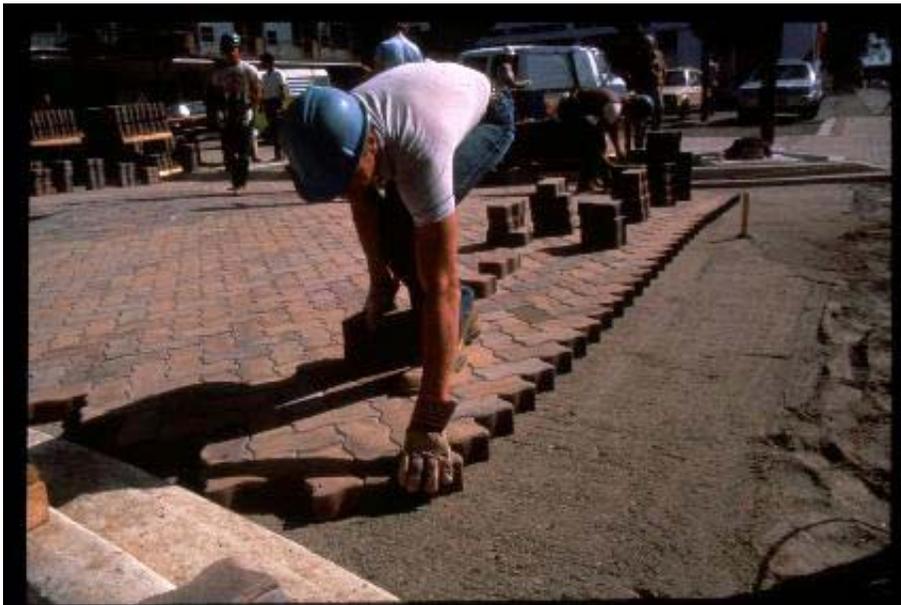
Figure V: Installation of the pavers on Main Street, North Bay – Note the 45-degree herringbone pattern utilizing Type 1 – wavy edged, 80 mm thick concrete pavers.

roadway pavers were 80mm thick and were laid in a herringbone pattern. The paver shape was, at that time, called Type 1, which are wavy edged in shape (See figure V). The paver thickness, shape and laying pattern were selected based upon the expert advice provided at the *Paving Stone 83 Seminar*. Other key engineering recommendations from the seminar included the need for proper drainage, compaction of the granular base to specification, proper edge restraint and the importance of using a concrete paver manufactured to high standards, particularly to resist freeze-thaw cycles in a salt-laden environment.

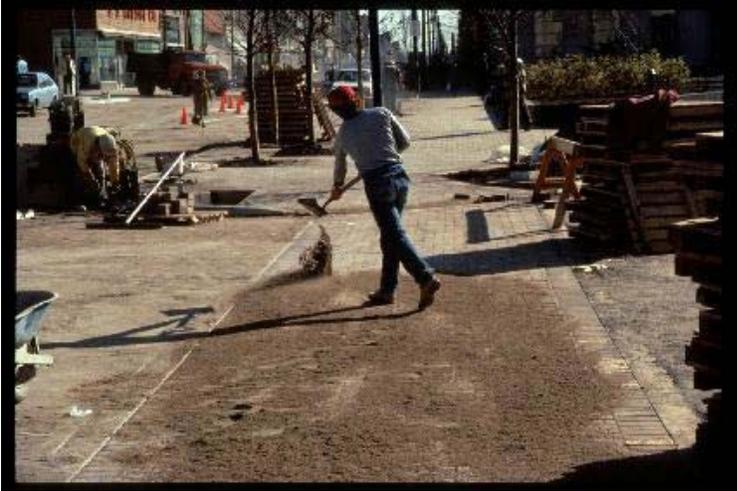
Figure VI: Joint Sand is spread on the pavement. Also of note is the soldier course used on pedestrian areas adjacent to the cast-in-place concrete edge restraint.

Edge restraint for the pavement consisted of standard concrete curb and gutter in the longitudinal direction and a 200 mm wide concrete curb laterally at the pedestrian crosswalks. A soldier course pattern was also integrated at some of the pavement edges. The joints between the pavers were filled with fine-graded mortar sand (See Figure VI) as per industry recommendations (3).

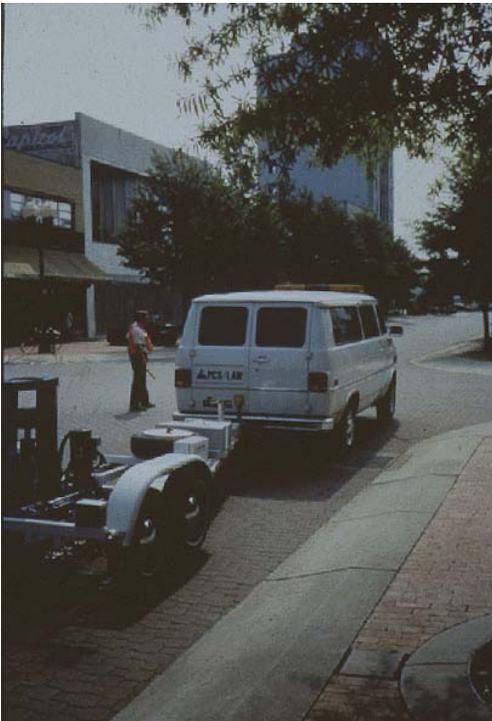
Figure VII: FWD testing utilized a Dynatest Model 8002 similar to the one pictured above

Approximately 8 years after the project completion PCS/Law Consulting Engineers conducted a detailed condition survey along with non-destructive deflection testing. For the deflection testing, a Dynatest model 8002 falling weight deflectometer (FWD) was used to determine the structural capacity of the pavements. This is a trailer-mounted device (See figure VII) capable of applying impulse loads from 13 to 134 kN (3,000 to 30,000 pounds). For this study, however, deflection tests were conducted using nominal impulse loads of 22 to 40 kN.

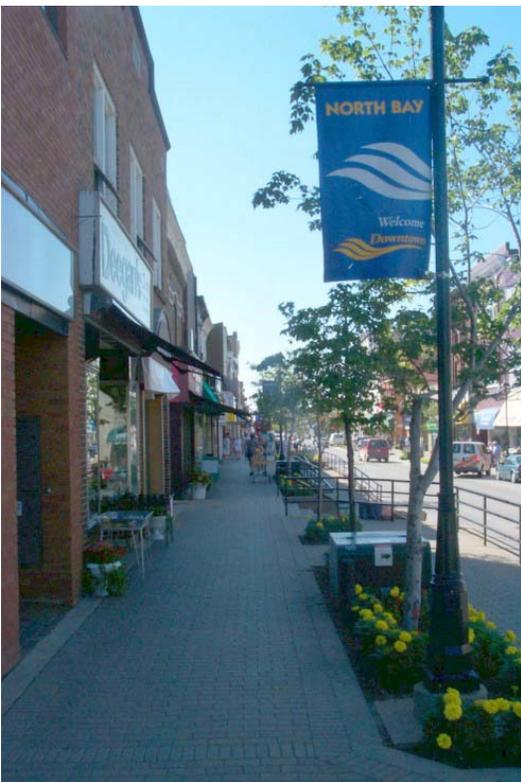
Figure IX: The back of sidewalk cast-in-place edge restraint at the building interface was beneficial both from a uniform visual appearance and with offering an easy way to set grades for the back of sidewalk

In addition to the structural benefit, the back of sidewalk cast-in-place edge restraint at the building interface was beneficial both from a uniform visual appearance and with offering an easy way to set grades for the back of sidewalk (See Figure IX). The project designer's attention to detail and the flexibility of the surface elevation allowed the designers to eliminate dozens of steps and trip hazards that were previously part of the old urban landscape.
